Annual Report Attachment 2 – Post Audit Photographs

County Government Center – 701 Ocean Street

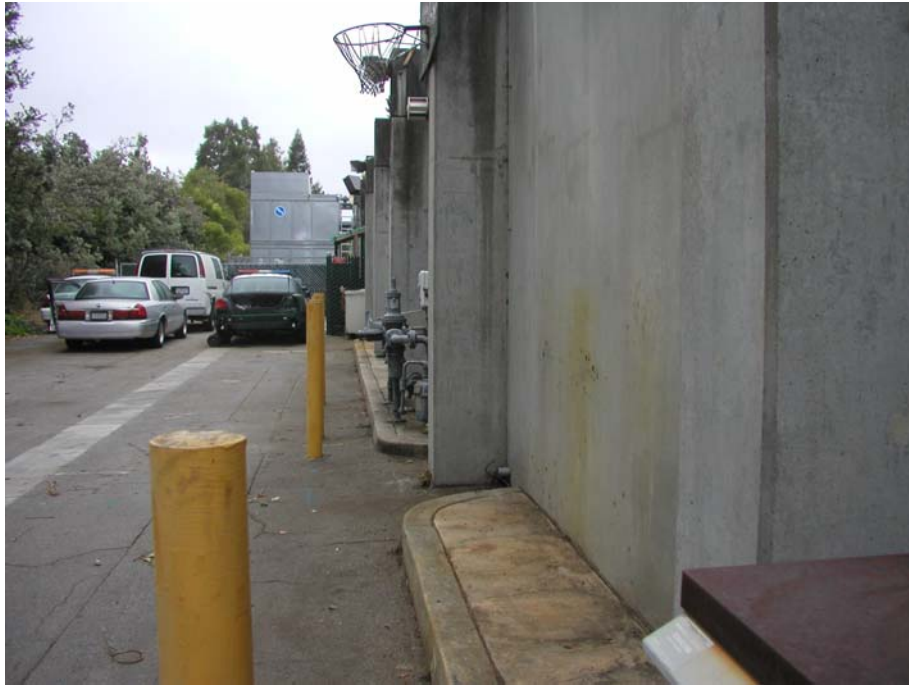
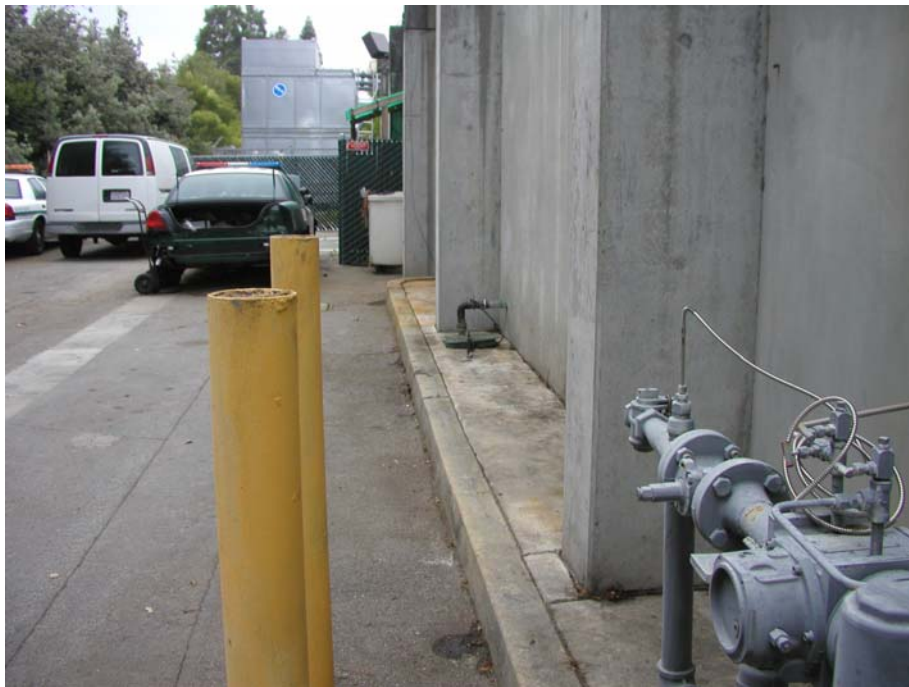
Photographs 1 and 2: Outside material storage cleaned up.

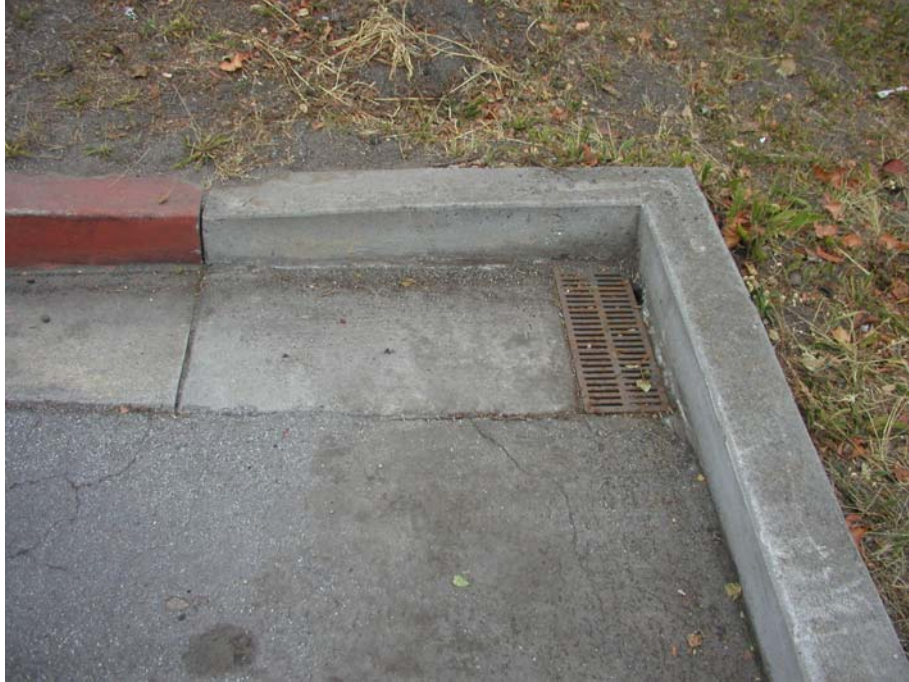
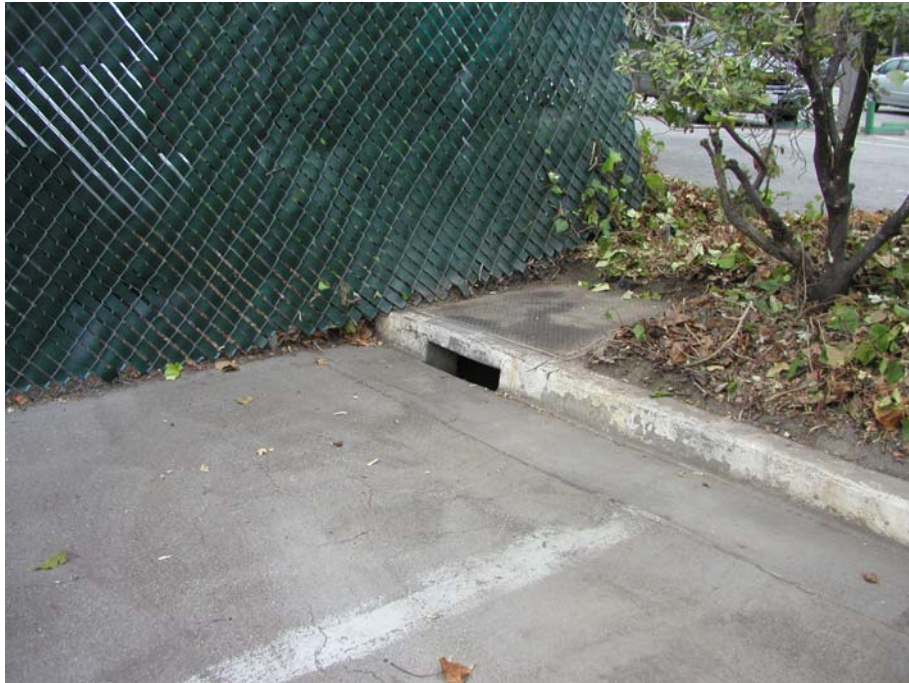
Photographs 3 and 4: Cleaned storm drain inlets.

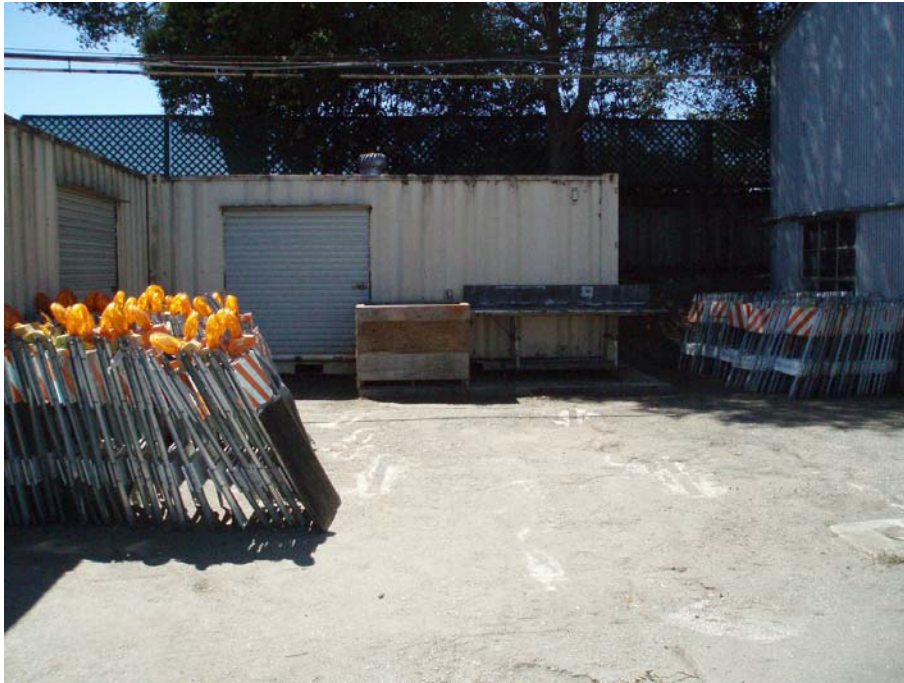
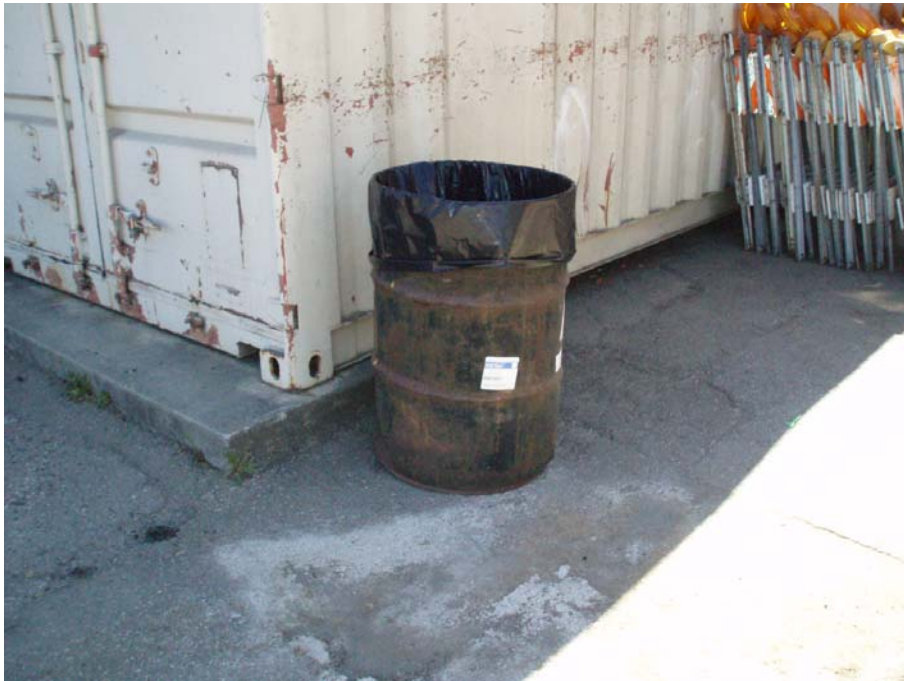
Photographs 5 and 6: Outside material storage cleaned up.

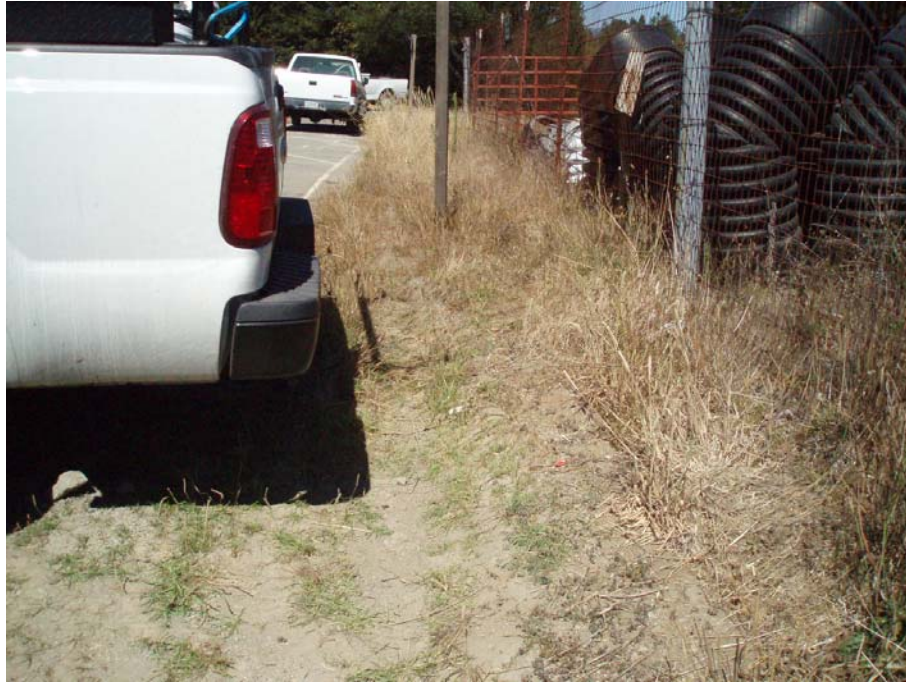
Photograph 7: Swale cleaned out.

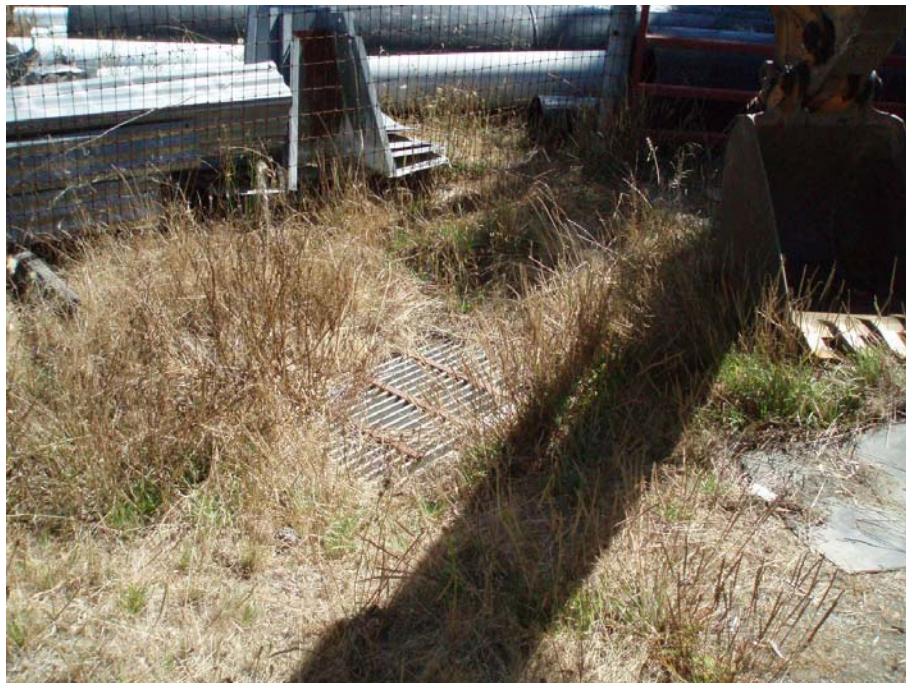
Photograph 8: Downstream inlet.

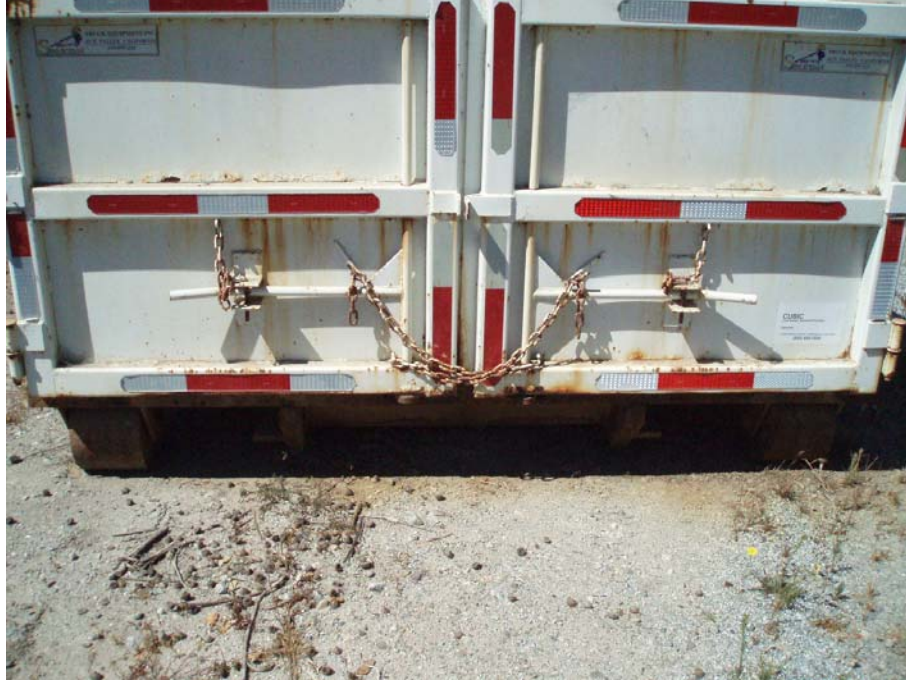
Photograph 9: Covered metal storage bin.

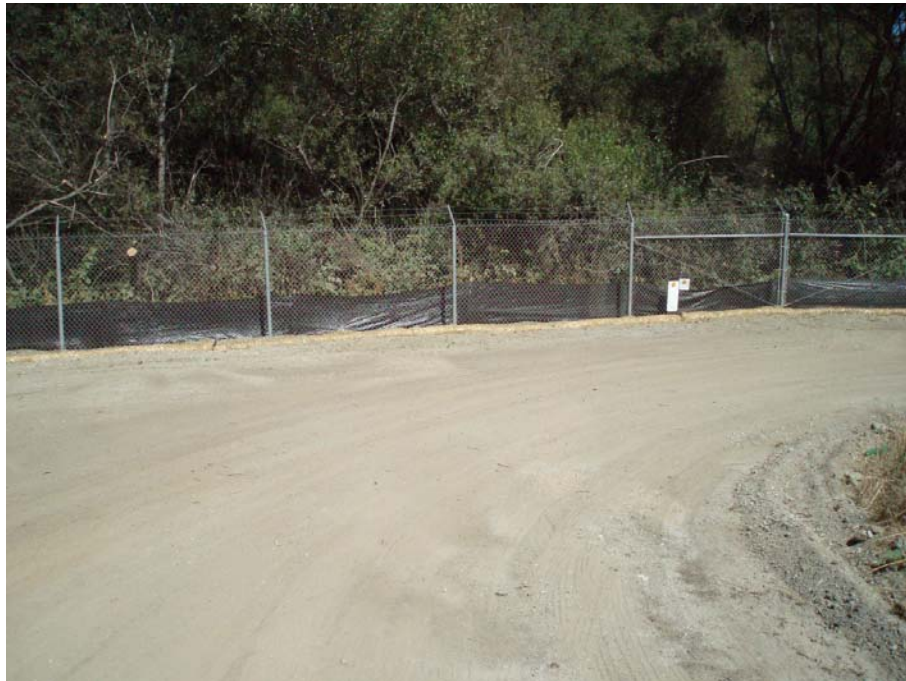
Photograph 10: Eastern boundary of maintenance yard, Rodeo Gulch riparian corridor behind fence. Perimeter controls installed.

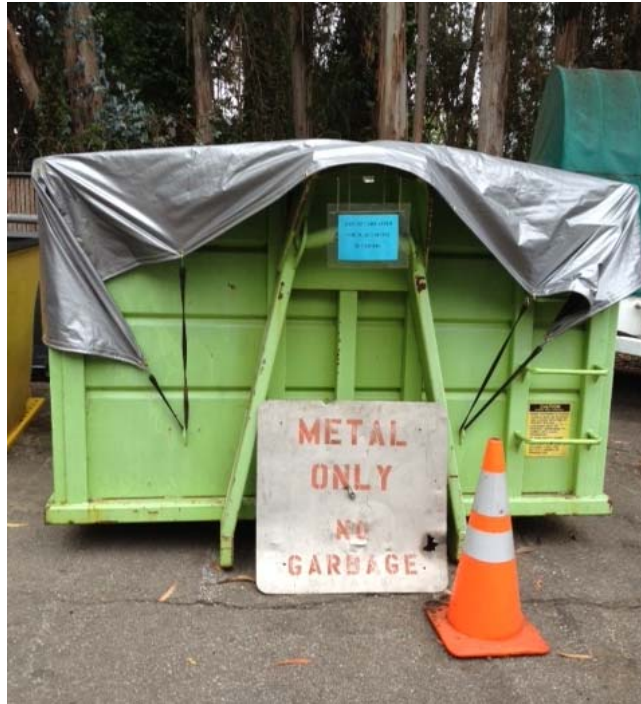
Photograph 11: Covered scrap metal bin.

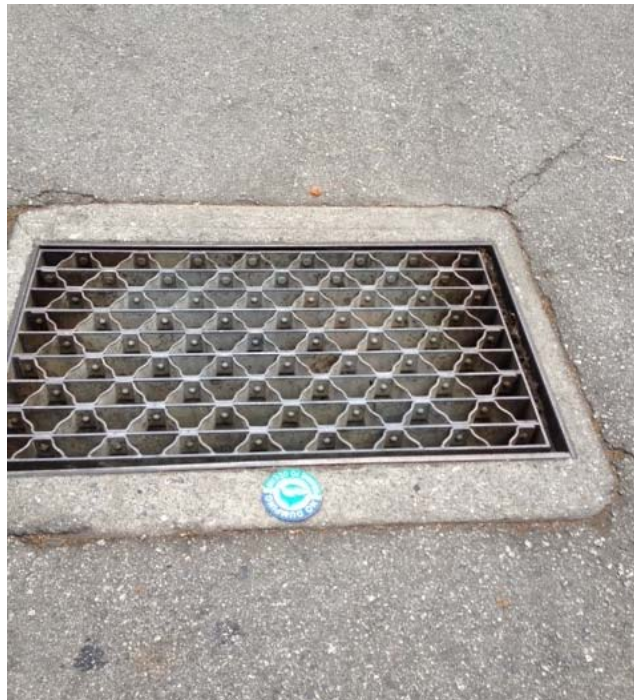
Photograph 12: Marked storm drain inlet in the parking area.
